Johnson County Concrete Board (JCCB) Web Site Helps Public Works Officials Standardize Quality Concrete in Johnson County

Durable Concrete

A report on the durability of existing aggregates, and recommendations for changes to specifications and ordinances relating to concrete

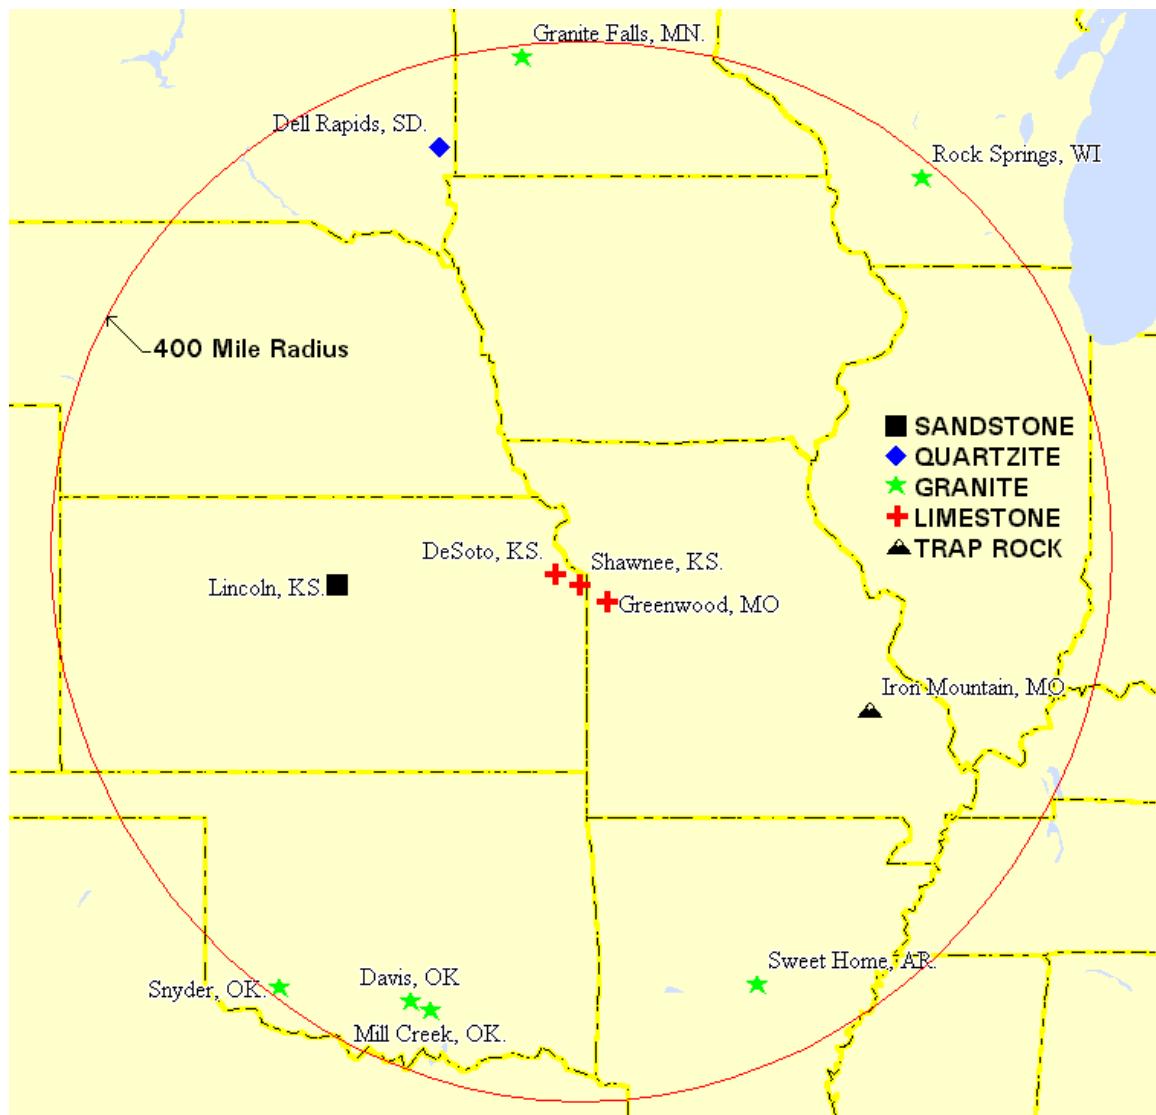
Sources for Concrete Aggregates

Coarse aggregate samples were obtained from several quarries all within 400 miles of the Kansas City metropolitan area. They represent a variety of geological types. Igneous samples include the granites from Oklahoma, Minnesota and Wisconsin, nepheline from Arkansas, and trap rock from Missouri. The quartzite from South Dakota is a metamorphic rock. All of the limestones and the sandstone from Lincoln, Kansas are sedimentary. Note that the sandstone comes from a company named Quartzite Stone, and is often referred to as quartzite. These samples do not represent every producer of rock within a 400-mile radius; rather they demonstrate that there are a variety of producers within that area. The map below shows the location of the quarries shown in the table. Kansas City, Missouri currently specifies and uses concrete that requires trap rock. The trap rock sample used in our tests came from a producer that has supplied concrete for Kansas City projects. The following table lists the aggregates tested by the CPG and by Overland Park. Note that several local limestone samples were added by the CPG, and were not included in the group being tested by Terracon for the City.

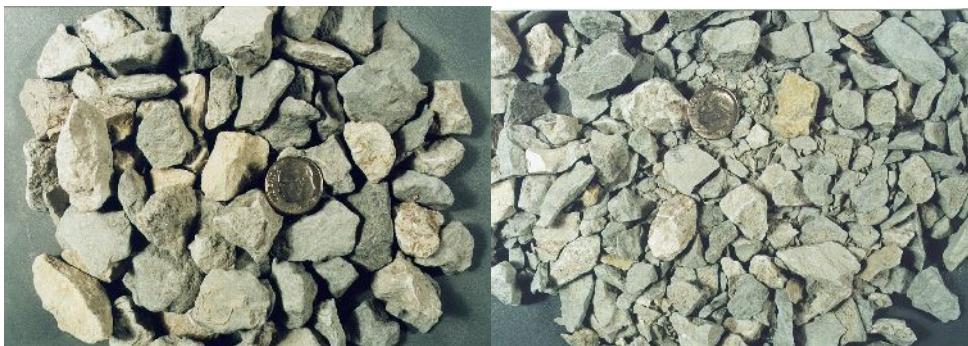
The results of the tests conducted by staff paralleled the preliminary results from Ash Grove. The photographs below show the results of fifty freeze thaw cycles on several of the rock specimens.

Before and after – Hunt Midwest C33 Limestone

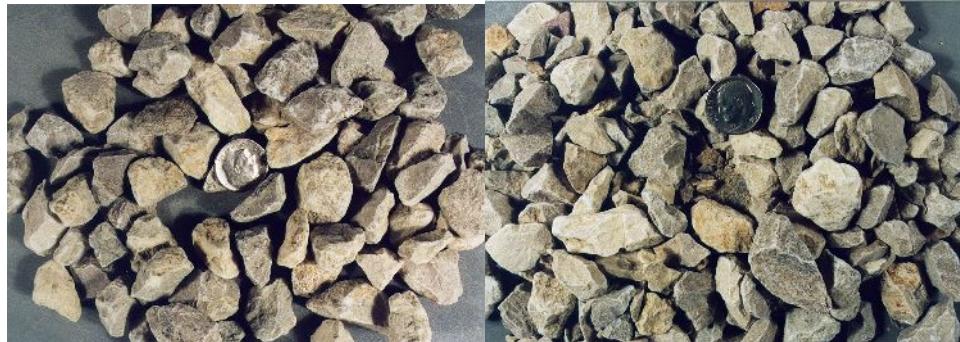
Before and after – Shawnee Rock-KDOT Class 1 Limestone

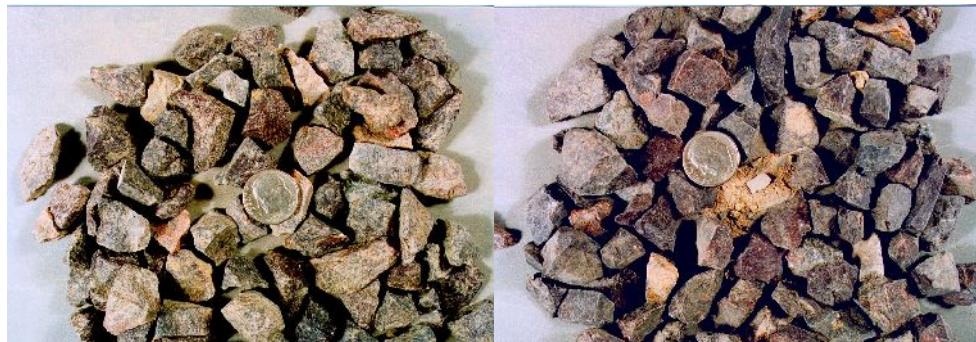
Before and after – Iron Mountain Trap Rock

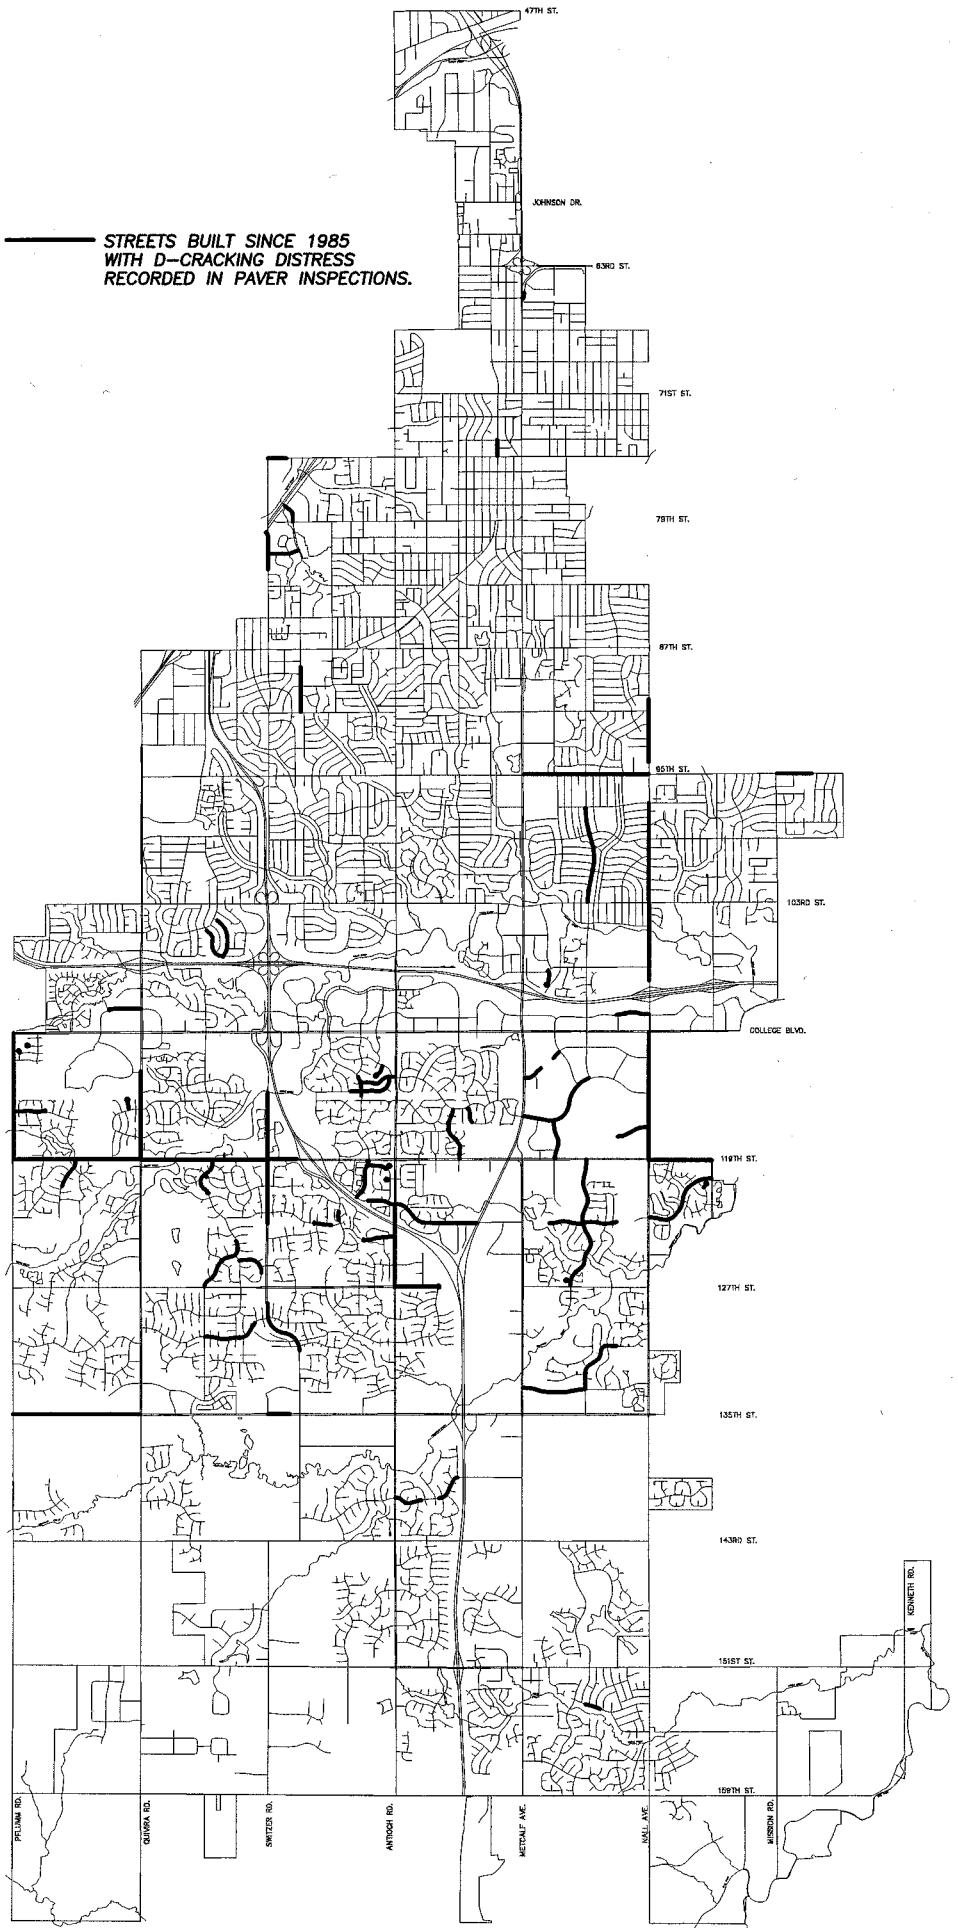
**STREETS BUILT SINCE 1985
WITH D-CRACKING DISTRESS
RECORDED IN PAVER INSPECTIONS.**

In conjunction with the testing, staff analyzed the curb condition for those curbs constructed after the change in concrete specification to the durable aggregate. Attached are maps that shows streets which exhibited signs of durability related distresses in the 1996 and 1997 PAVER street inspection programs. One map shows streets where at least 5% of the curb sections have D-Cracking. The second map shows streets where at least 20% of the curb sections have D-Cracking. Both maps differentiate those streets which are less than 15 years old, and which were constructed using the KDOT durable aggregate. Distress at a 5% level is worth noting, but would not require further action. At the 20% level we would anticipate adding those streets to a curb replacement program in the near future, and would perform further inspections to establish priorities and to verify their condition.
